P.I.N. X051.59  
BRIDGE DECK EVALUATION REPORT

<u>Description:</u>	Grand Central Parkway over Winchester Blvd and Cross Island Parkway and Ramp "H" over Cross Island Parkway
<u>BIN:</u>	1065149 and 106514A
<u>GCP Reference Marker:</u>	1120 to 1124
<u>County:</u>	Queens
<u>City of:</u>	New York
<u>Region:</u>	11
<u>Feature Carried:</u>	Grand Central Parkway and GCP Ramp "H"
<u>Feature Crossed:</u>	Cross Island Parkway Winchester Blvd

# IN-DEPTH INSPECTION REPORT

**B.I.N. 1-06514-9 & 1-06514-A**

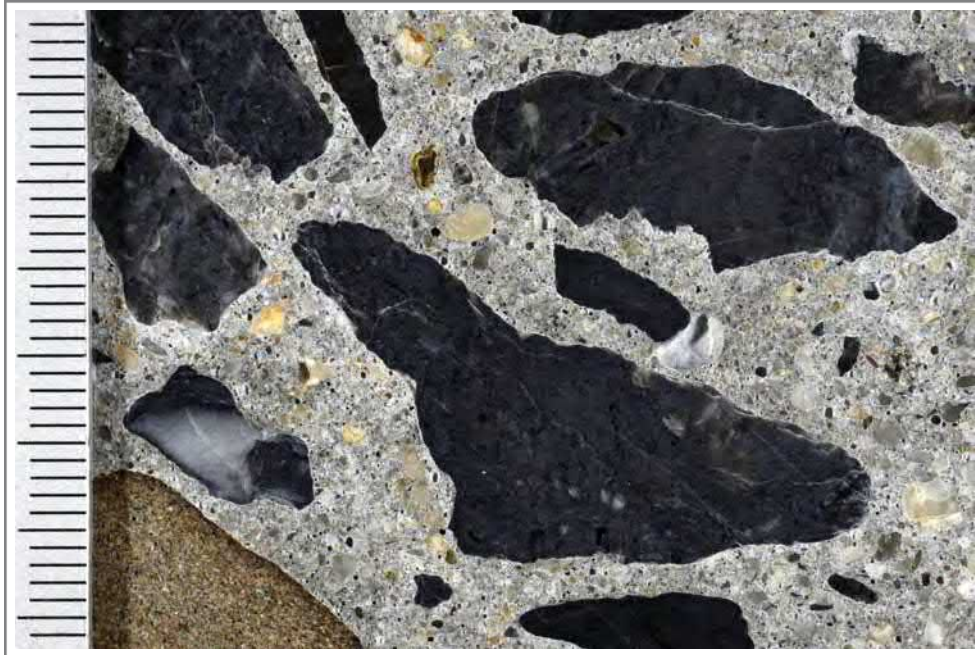
PHYSICAL PROPERTIES	The coarse aggregate is a crushed carbonate rock with a 19 mm (¾ in.) nominal top size ( <b>Figure B7</b> ). The rocks are hard and competent. The particles are equant to elongated in shape with angular to sub-angular edges and rough surfaces. Aggregate distribution is somewhat non-uniform and gradation is fairly uneven with a low volume of intermediate sized particles. No aggregate segregation is observed.
ROCK TYPES	The coarse aggregate is carbonate in composition and consists of limestone. Some particles exhibit minor to trace amounts of quartz, chert, and/or pyrite. Particles containing siliceous material (quartz, chert) are potentially susceptible to alkali-silica reaction (ASR). No particles are potentially susceptible to alkali-carbonate reaction (ACR); carbonate particles do not contain dolomite or textural characteristics typical of potentially reactive aggregate.

**Figure B7. Photograph of the polished surface showing detail of the coarse aggregate. Scale shows millimeter increments.**

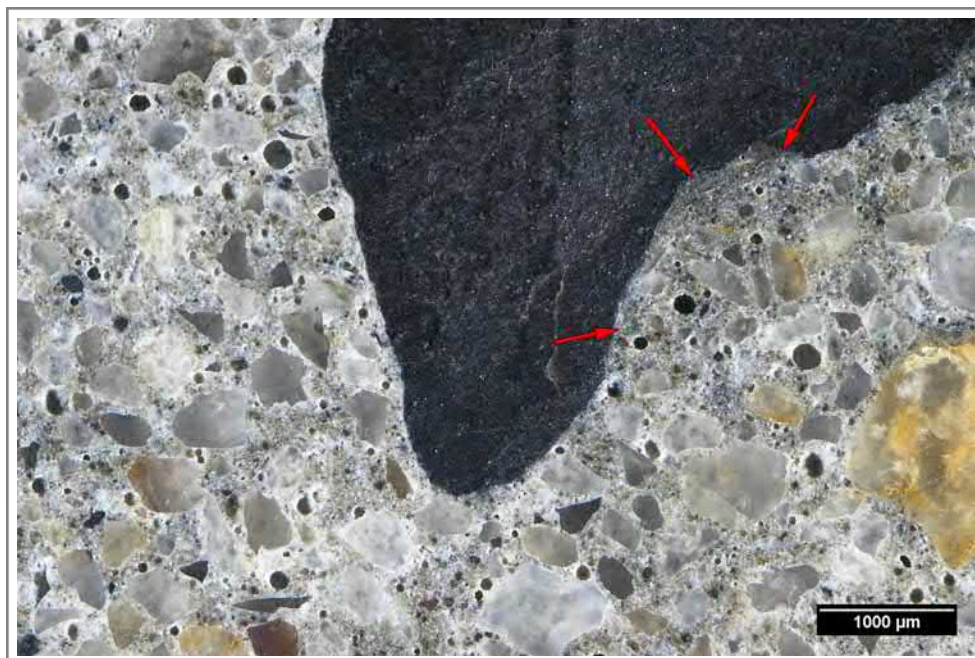
OTHER FEATURES	No evidence of ASR or ACR is observed. No deleterious coatings or encrustation are observed. Rare low w/c mortar coatings are observed ( <b>Figure B8</b> ).

**Figure B8. Reflected light photomicrograph of the polished surface showing low w/cm mortar coating (red arrows) along a coarse aggregate particle.**

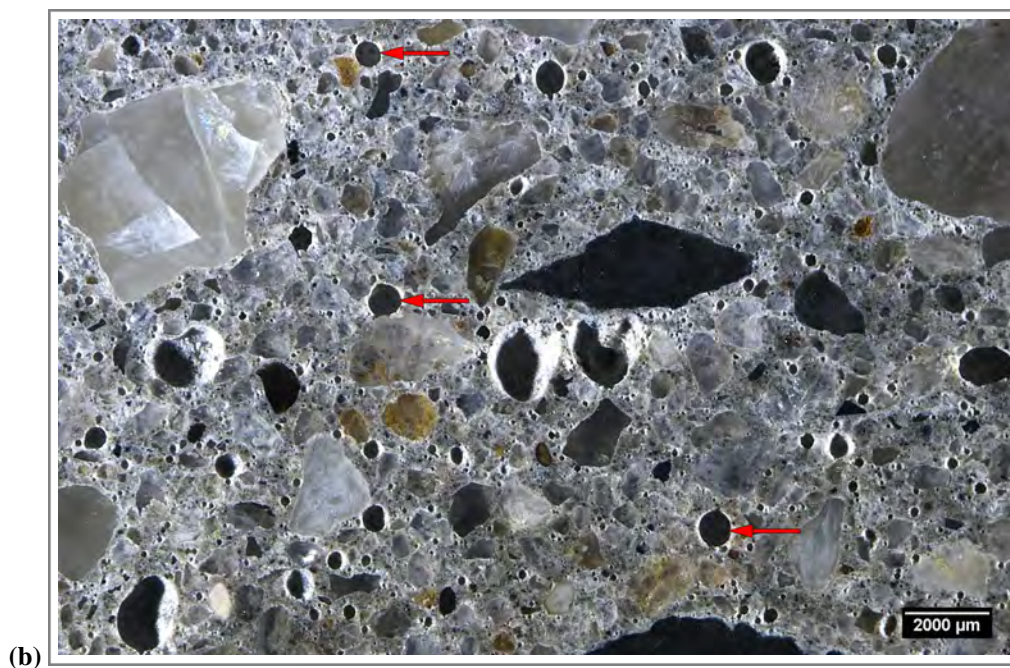
VOID SYSTEM	The concrete is air-entrained and has an estimated 6-7% total air content. Several spherical voids are observed throughout the depth of the core ( <b>Figure B10</b> ). Few entrapped voids are occasionally present throughout the core. The concrete is well consolidated with no notably large entrapped voids.
VOID FILLINGS	Ettringite occasionally lines voids throughout the core ( <b>Figure B11</b> ).

**Figure B10 (cont'd). Images showing detail of voids within the core. (b) Reflected light photomicrograph showing detail of voids (red arrows) in the middle of the core.**

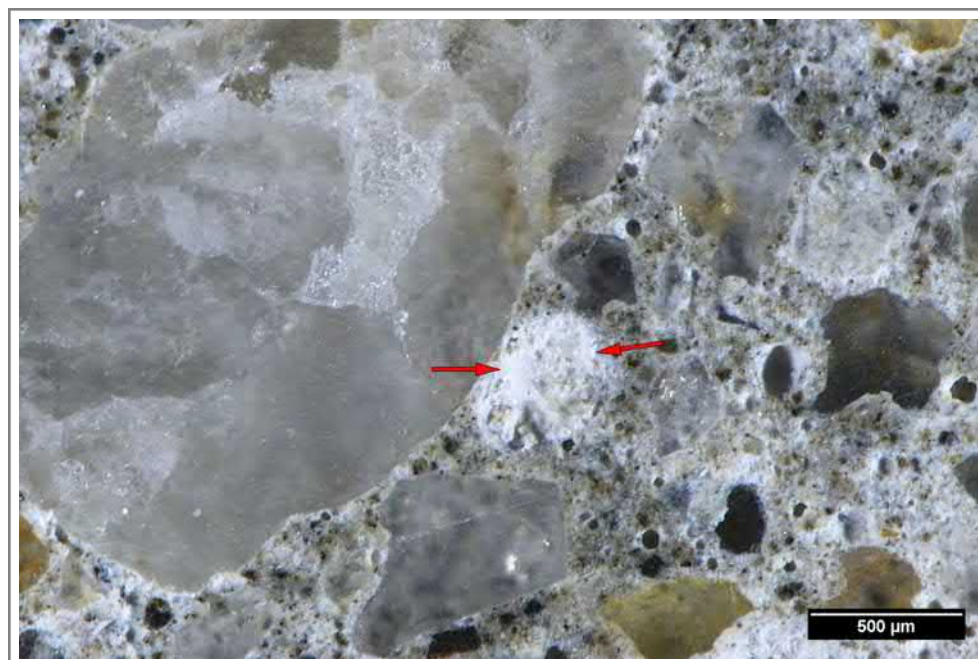
**Figure B11. Reflected light photomicrograph of the polished surface showing ettringite (red arrows) in a void within the core.**

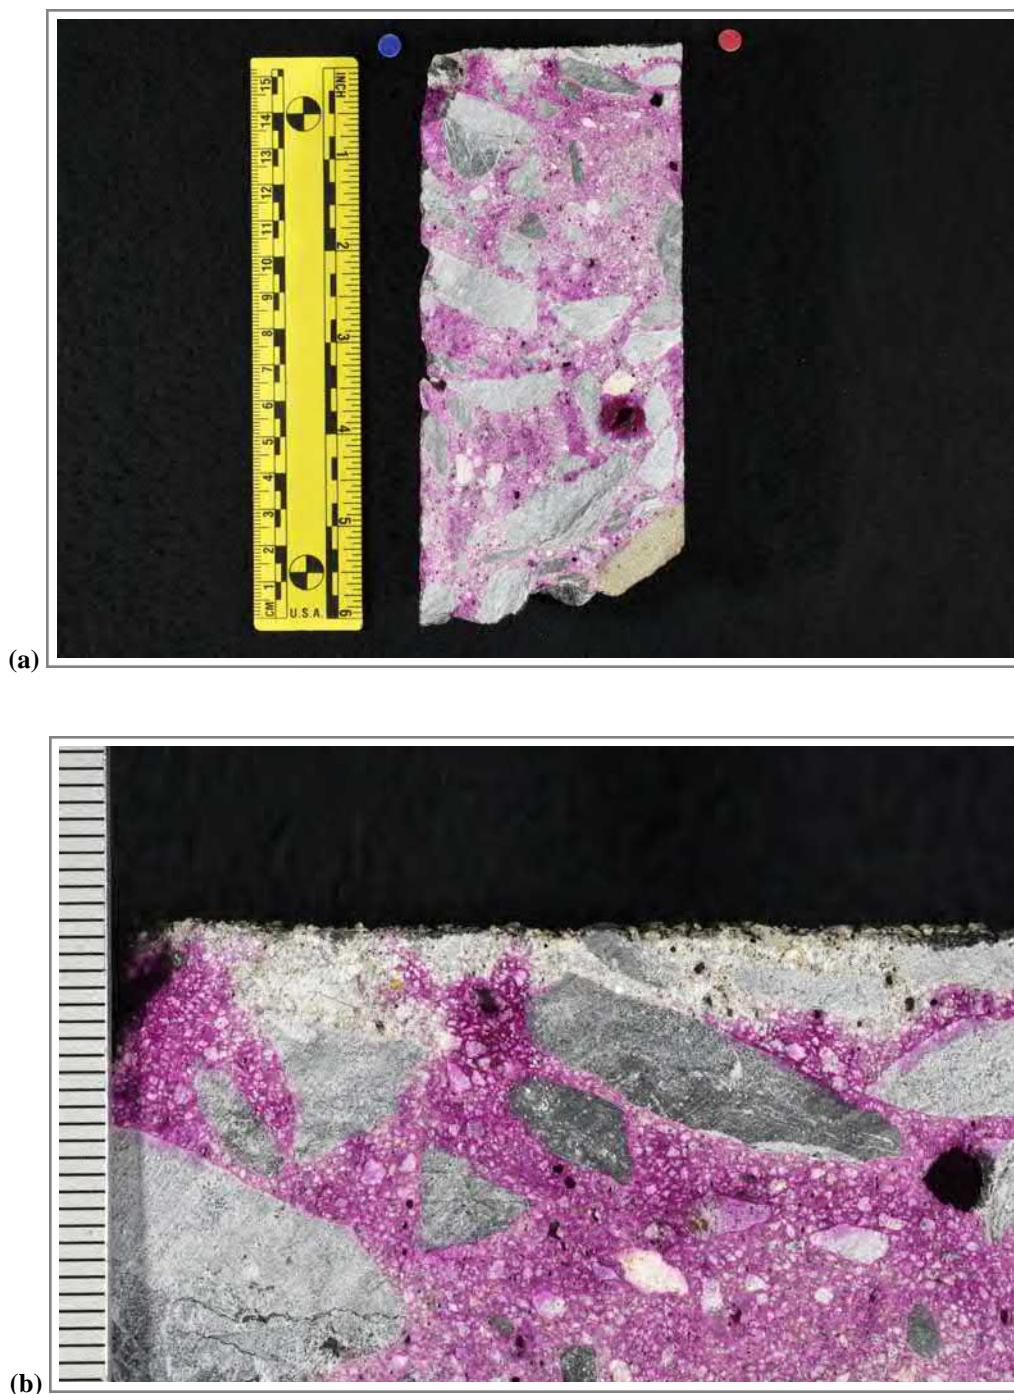
PHENOLPHTHALEIN	The paste is carbonated in the top 1 mm (40 mil) with locally deeper carbonation along sub-vertical microcracks ( <b>Figure B12</b> ). Phenolphthalein staining was applied to a freshly saw-cut cross-sectional surface of the core to determine general depth of paste carbonation.
SECONDARY DEPOSITS	Other than ettringite in voids, no additional secondary deposits are observed.

Figure B12. Photographs showing (a) overview of phenolphthalein-stained cross-sectional surface of the core, and (b) detail of stained surface at the top of the core. The yellow scale in (a) is ~150 mm (6 in.) long; the small and large divisions are in centimeters and inches, respectively. The scale in (b) shows millimeter increments.

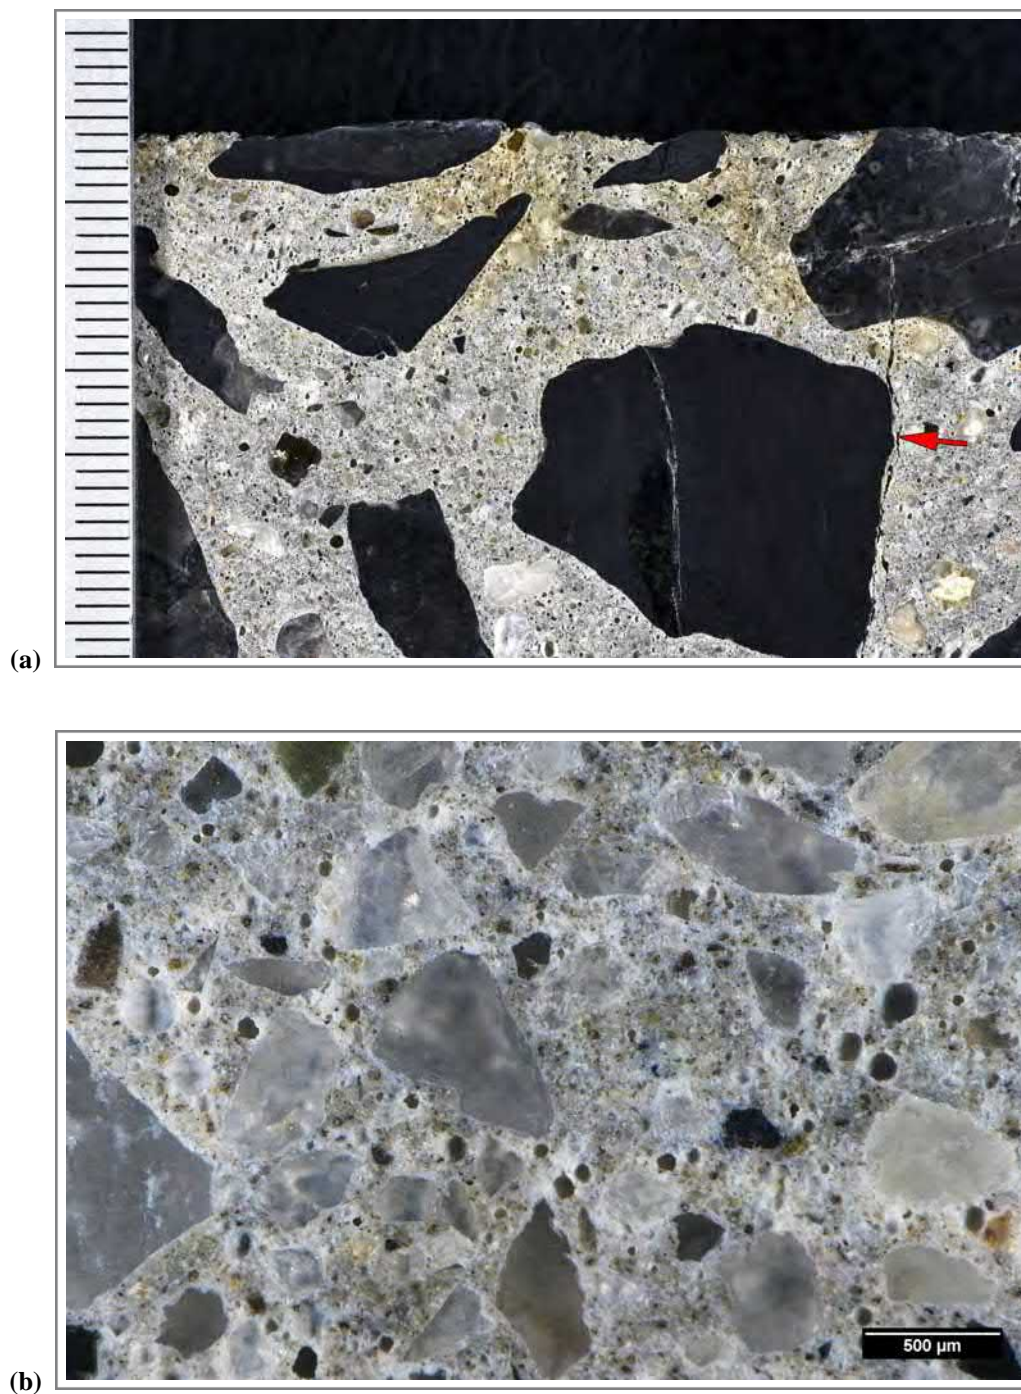
POLISHED SURFACE	Paste in the top 12 mm (½ in.) is locally light beige; remainder of paste is light gray (Munsell Soil Color GLEY 1 7/N) ( <b>Figure C6</b> ). Paste throughout the core is hard (Mohs 3.5-4). The paste has a smooth texture and sub-vitreous luster.
FRESH FRACTURE	Freshly fractured surfaces show same coloration and luster, and exhibit a moderately weak paste-aggregate bond such that the concrete fractures around ~75% of coarse aggregate particles when struck with a geology hammer in the petrographic laboratory ( <b>Figure C7</b> ).
THIN SECTION	The paste contains hydrated portland cement with no supplemental cementitious materials ( <b>Figure C8</b> ). The amount of observed residual portland cement is estimated at 10-15% by volume of paste. Cement hydration appears normal. Calcium hydroxide is medium to coarse grained and the observed amount is estimated at 2-7% by volume of paste. Limestone fines are common in the paste.

**Figure C6. Images showing detail of the paste. (a) Photograph showing paste in the near-surface region of the core. Scale shows millimeter increments. (b) Reflected light photomicrograph showing paste detail in the body of the core.**

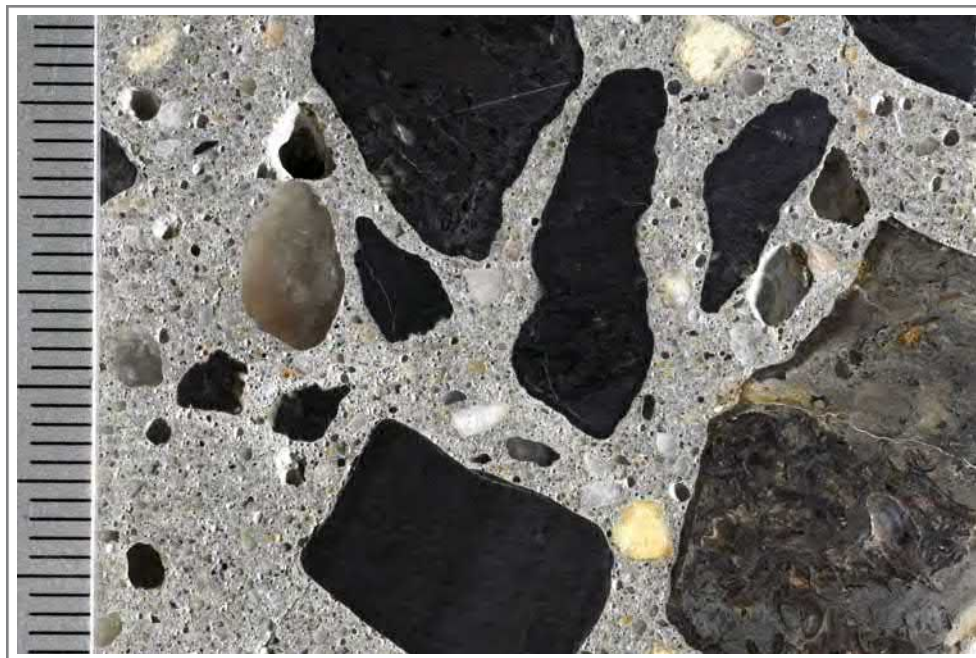
PHYSICAL PROPERTIES	The coarse aggregate is a crushed carbonate rock with a 19 mm (¾ in.) nominal top size ( <b>Figure C10</b> ). The rocks are hard and competent. The particles are equant to elongated in shape with angular to sub-angular edges and rough surfaces. Aggregate distribution is somewhat non-uniform and gradation is fairly uneven with a low volume of intermediate sized particles. No aggregate segregation is observed.
ROCK TYPES	The coarse aggregate is carbonate in composition and consists of limestone. Some particles exhibit minor to trace amounts of quartz, chert, and/or pyrite ( <b>Figure C11</b> ). Particles containing siliceous material (quartz, chert) are potentially susceptible to alkali-silica reaction (ASR). No particles are potentially susceptible to alkali-carbonate reaction (ACR); carbonate particles do not contain dolomite or textural characteristics typical of potentially reactive aggregate.

**Figure C10.** Photograph of the polished surface showing detail of the coarse aggregate. Scale shows millimeter increments.

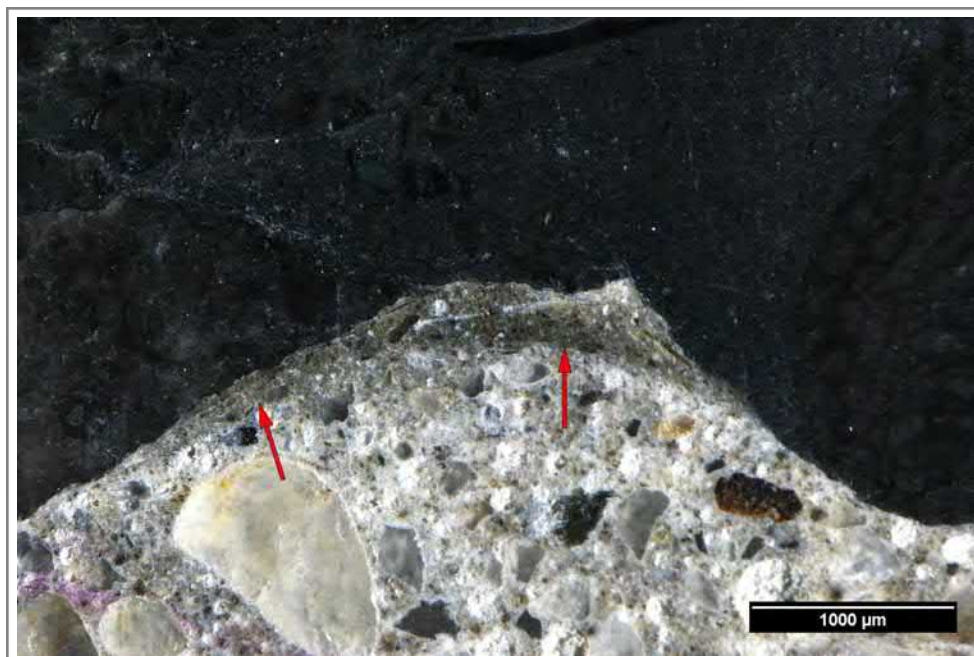
OTHER FEATURES	Evidence of ASR is present in the form of trace ASR gel in rare microcracks extending outwardly from reactive coarse aggregate particles and ASR gel lining to filling rare voids adjacent to reactive coarse aggregate particles. No evidence of ACR is observed. No deleterious coatings or encrustation are observed. Rare low w/c coatings are observed ( <b>Figure C12</b> ).

**Figure C12.** Reflected light photomicrograph of the polished surface showing low w/cm mortar coating (red arrows) along a coarse aggregate particle.

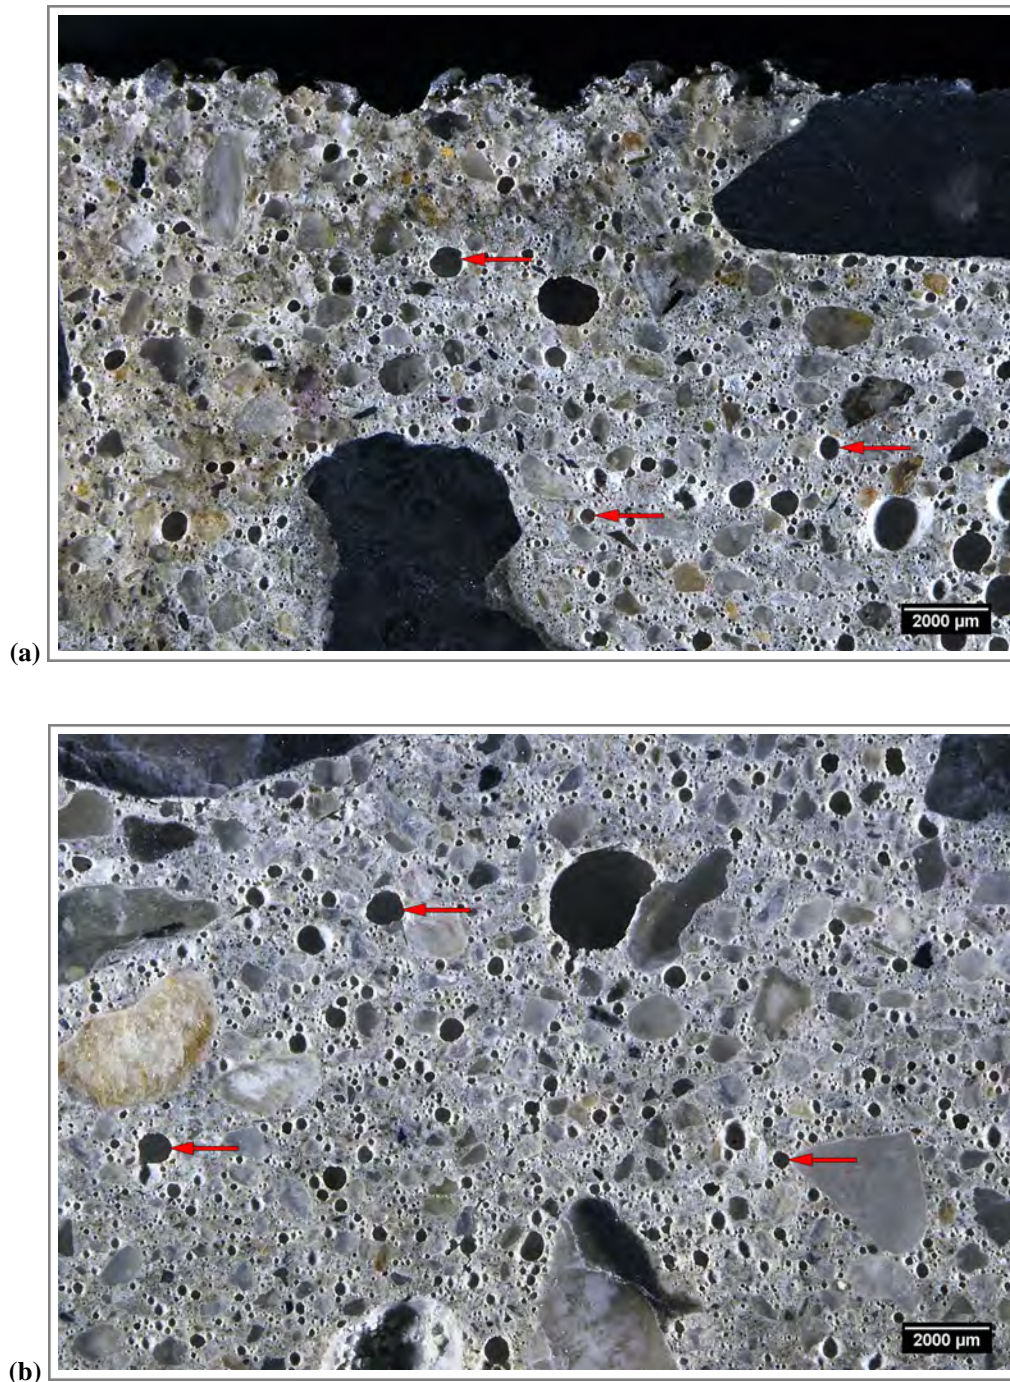
VOID SYSTEM	The concrete is air-entrained and has an estimated 6-7% total air content. Several spherical voids are observed throughout the depth of the core ( <b>Figure C14</b> ). Few entrapped voids are occasionally present throughout the core. The concrete is well consolidated with no notably large entrapped voids. Air void clustering is observed along the boundaries of coarse aggregate particles. Gaps between coarse aggregate and paste is observed in regions of air void clustering.
VOID FILLINGS	Ettringite occasionally lines voids throughout the core ( <b>Figure C15</b> ).

**Figure C14. Images showing detail of voids within the core. (a) Reflected light photomicrograph showing detail of voids (red arrows) in the top portion of the core. (b) Reflected light photomicrograph showing detail of voids (red arrows) in the middle of the core. (c) Reflected light photomicrograph showing detail of air void clustering (encircled red) along coarse aggregate particle and gaps between aggregate and paste (yellow arrows).**

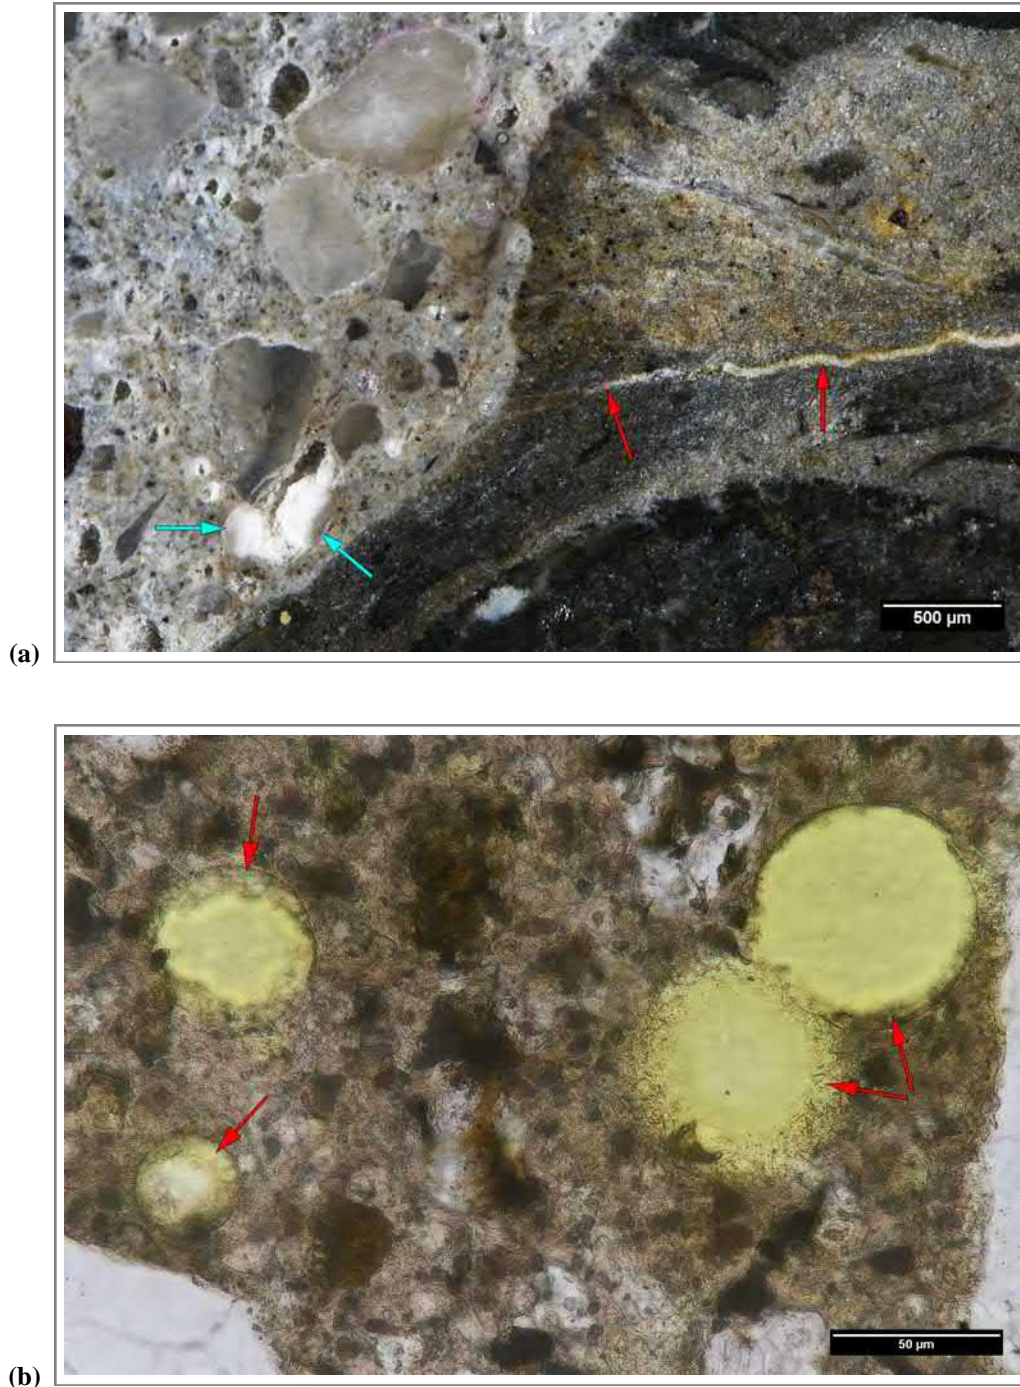
**Figure C15. Images showing secondary deposits in voids. (a) Reflected light photomicrograph of the polished surface showing ASR gel-filled microcrack (red arrows) extending through a coarse aggregate particle and ASR gel partially filling a void (blue arrows). (b) Transmitted plane-polarized light thin section photomicrograph showing ettringite (red arrows) in voids.**

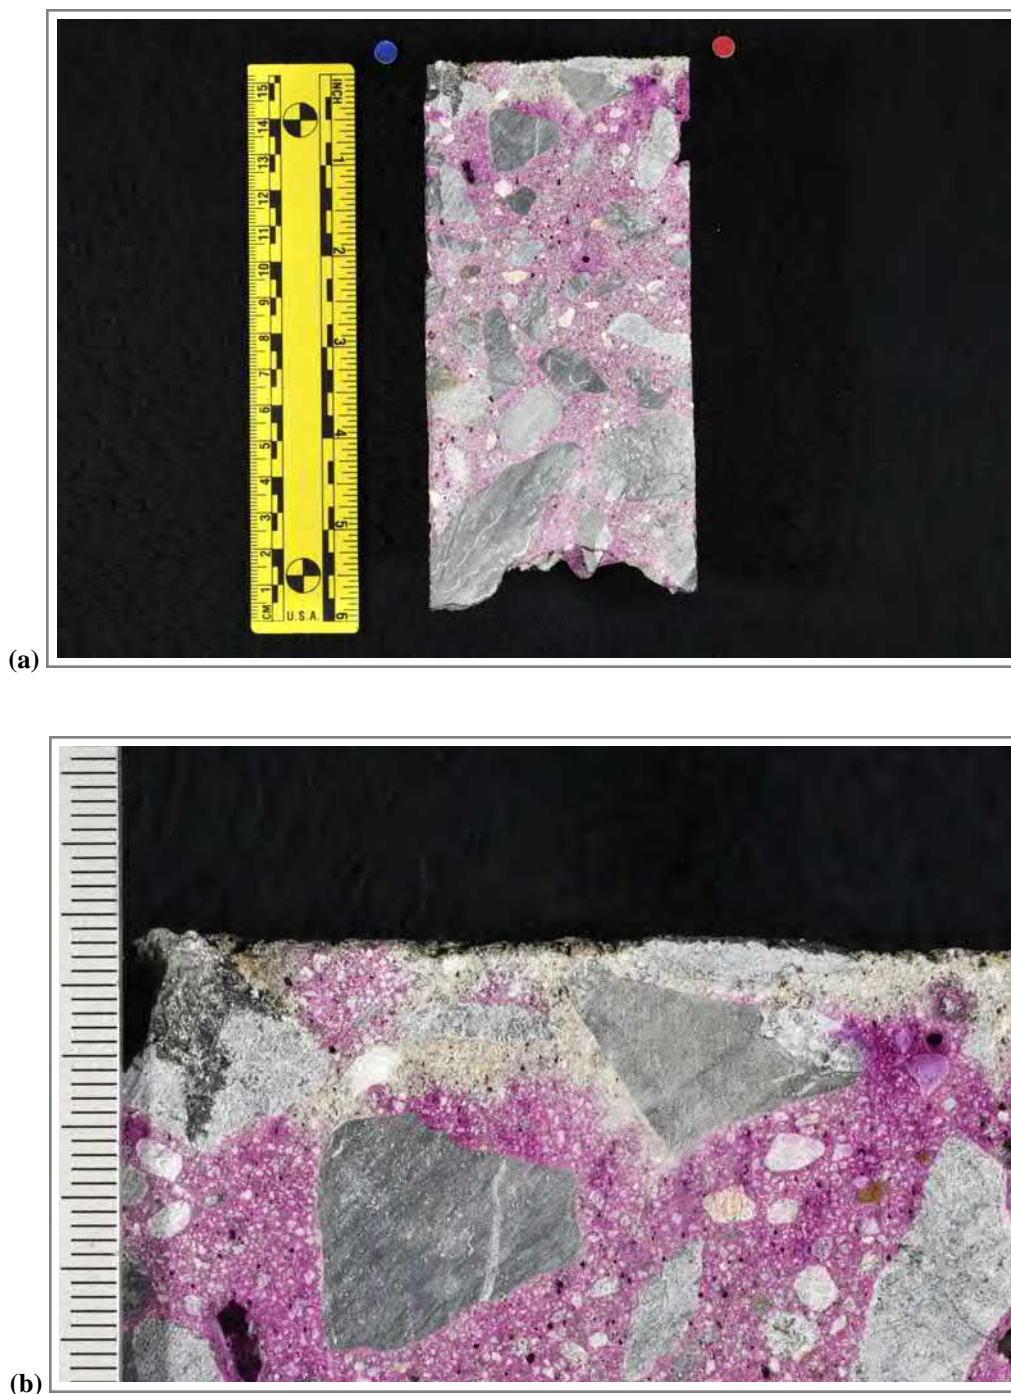
PHENOLPHTHALEIN	The paste is carbonated in the top 1 mm (40 mil) with locally deeper carbonation along sub-vertical cracks and microcracks ( <b>Figure C16</b> ). Phenolphthalein staining was applied to a freshly saw-cut cross-sectional surface of the core to determine general depth of paste carbonation and depth of paste carbonation was confirmed in thin section.
SECONDARY DEPOSITS	Other than ettringite in voids and ASR gel in microcracks and voids, no additional secondary deposits are observed.

Figure C16. Photographs showing (a) overview of phenolphthalein-stained cross-sectional surface of the core, and (b) detail of stained surface at the top of the core. The yellow scale in (a) is ~150 mm (6 in.) long; the small and large divisions are in centimeters and inches, respectively. The scale in (b) shows millimeter increments.

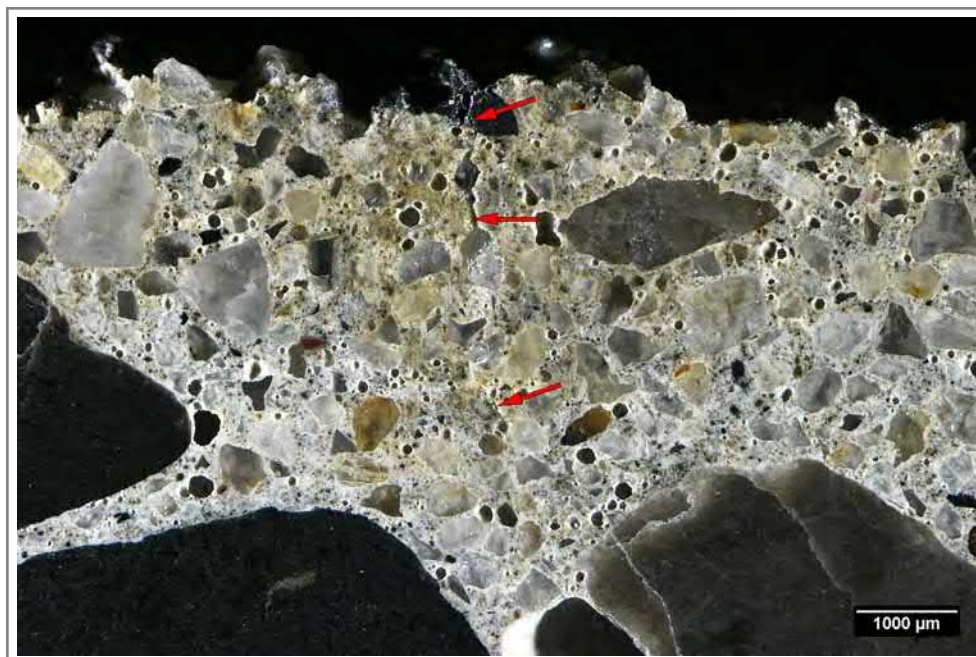
**Figure D4.** Reflected light photomicrograph showing detail of a sub-vertical microcrack (red arrows) in the near-surface region of the paste.

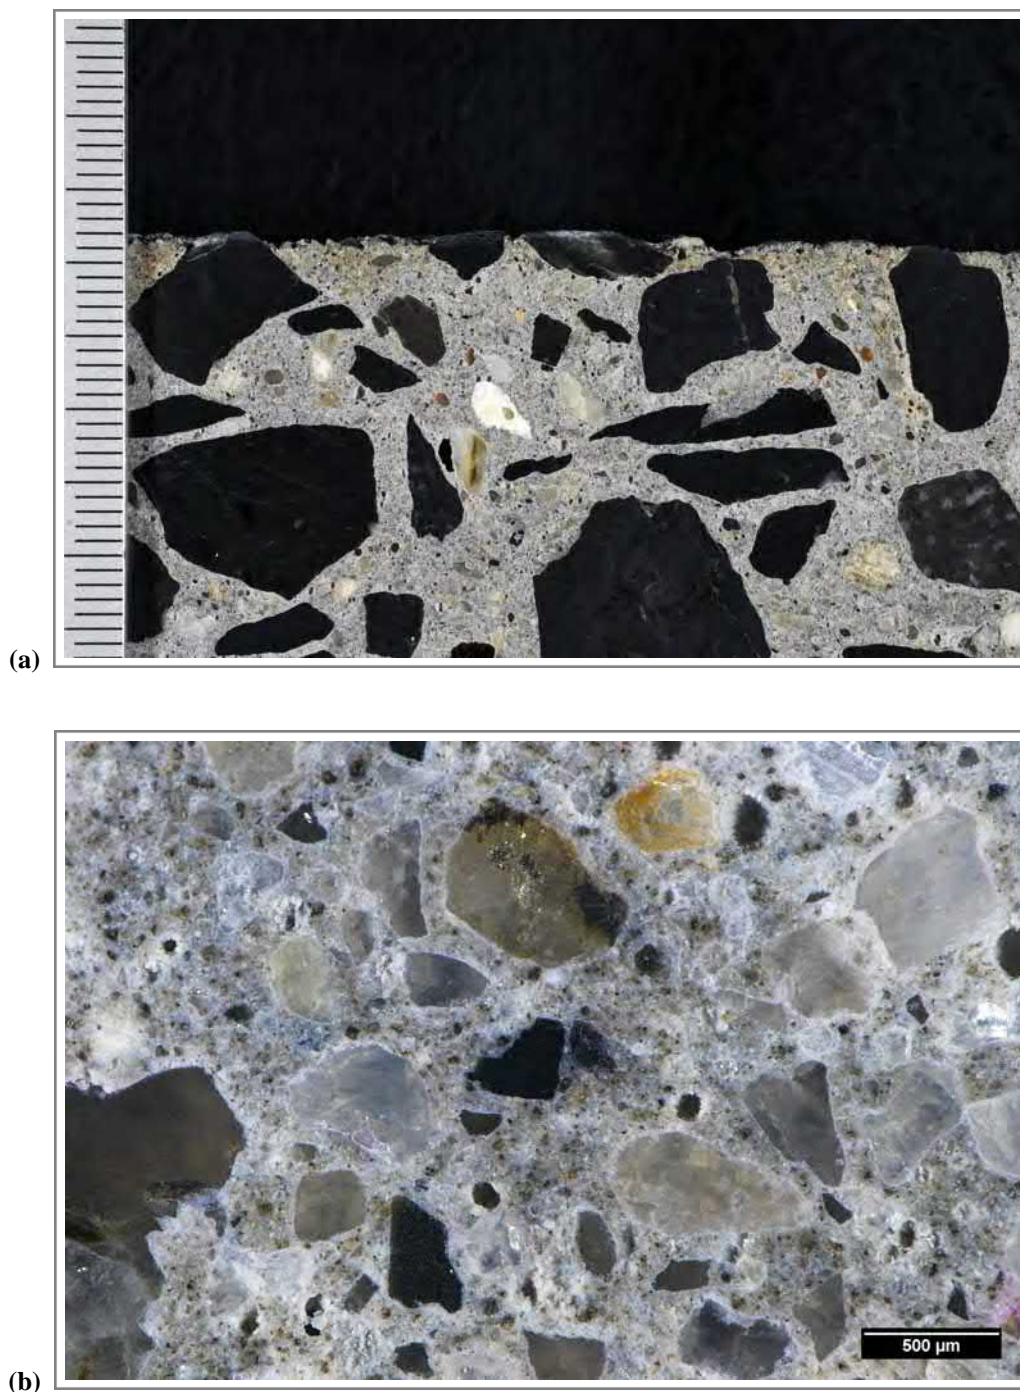
POLISHED SURFACE	Paste in the top 4 mm (¼ in.) is locally light beige; remainder of paste is light gray (Munsell Soil Color GLEY 1 7/N) ( <b>Figure D5</b> ). Paste throughout the core is hard (Mohs 3.5-4). The paste has a smooth texture and sub-vitreous luster.
FRESH FRACTURE	Freshly fractured surfaces show same coloration and luster, and exhibit a moderately weak paste-aggregate bond such that the concrete fractures around ~75% of coarse aggregate particles when struck with a geology hammer in the petrographic laboratory ( <b>Figure D6</b> ).
THIN SECTION	Thin section evaluation was not performed.
ESTIMATED W/C	Thin section evaluation was not performed; w/c was not estimated.

**Figure D5. Images showing detail of the paste. (a) Photograph showing paste in the near-surface region of the core. Scale shows millimeter increments. (b) Reflected light photomicrograph showing paste detail in the body of the core.**

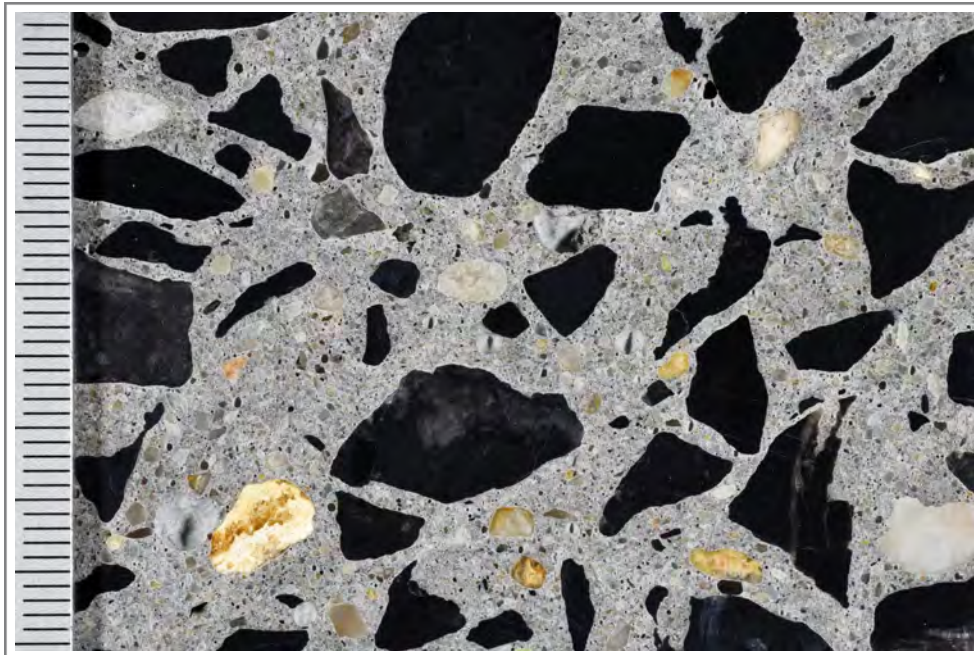
PHYSICAL PROPERTIES	The coarse aggregate is a crushed carbonate rock with a 19 mm (¾ in.) nominal top size ( <b>Figure D7</b> ). The rocks are hard and competent. The particles are equant to elongated in shape with angular to sub-angular edges and rough surfaces. Aggregate distribution is fairly uniform and gradation is fairly uneven with a low volume of intermediate sized particles. No aggregate segregation is observed.
ROCK TYPES	The coarse aggregate is carbonate in composition and consists of limestone. Some particles exhibit minor to trace amounts of quartz, chert, and/or pyrite. Particles containing siliceous material (quartz, chert) are potentially susceptible to alkali-silica reaction (ASR). No particles are potentially susceptible to alkali-carbonate reaction (ACR); carbonate particles do not contain dolomite or textural characteristics typical of potentially reactive aggregate.
OTHER FEATURES	No evidence of ASR or ACR is observed. No deleterious coatings or encrustation are observed. Rare low w/c mortar coatings are observed ( <b>Figure D8</b> ).

Figure D7. Photograph of the polished surface showing detail of the coarse aggregate. Scale shows millimeter increments.

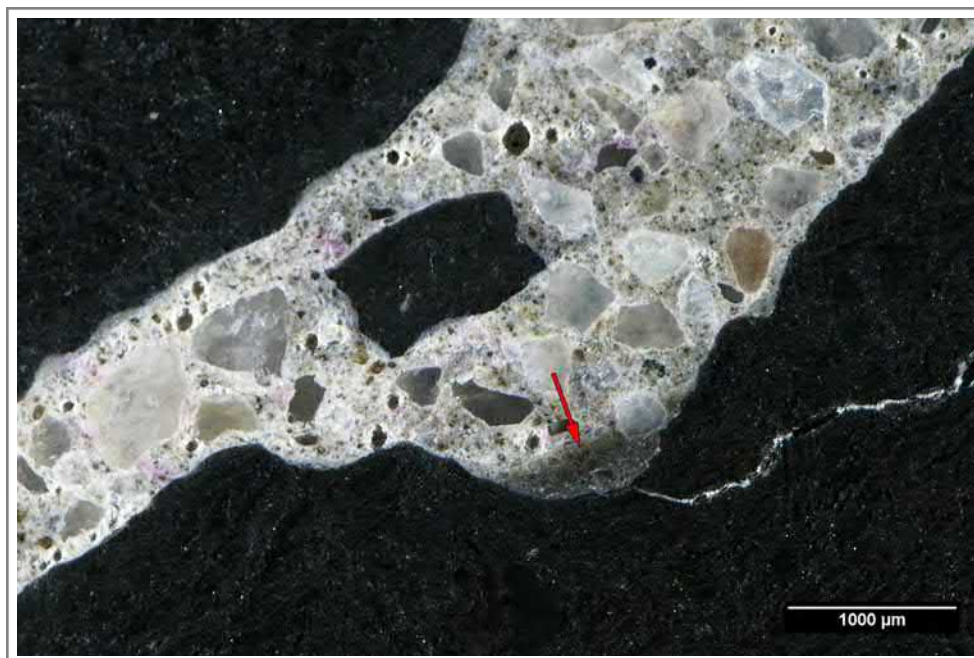
Figure D8. Reflected light photomicrograph of the polished surface showing low w/cm mortar coating (red arrows) along a coarse aggregate particle.

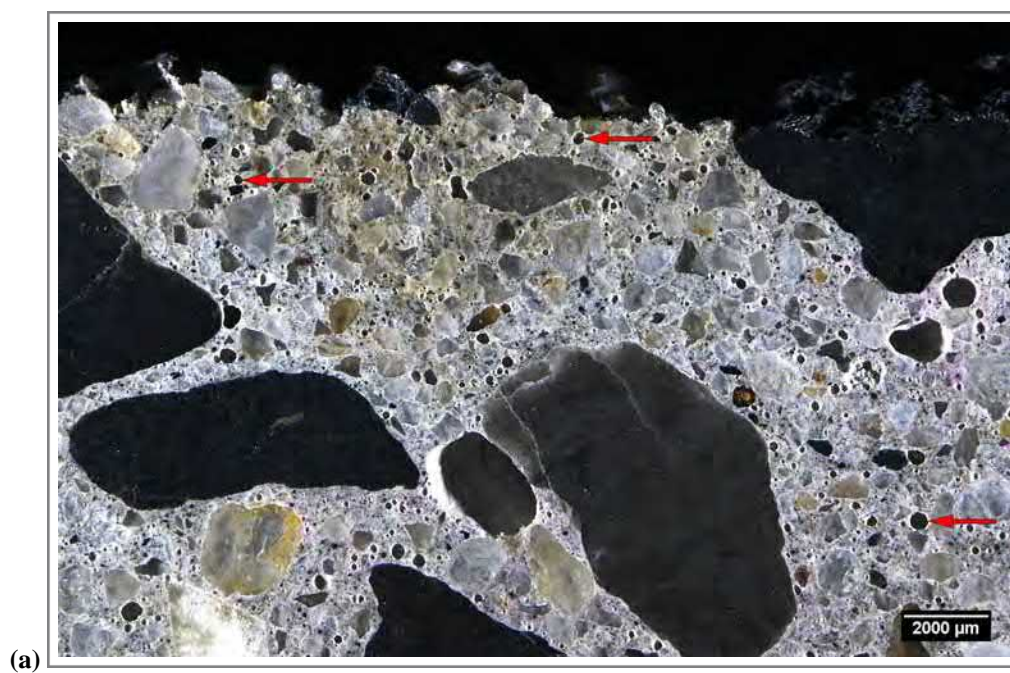
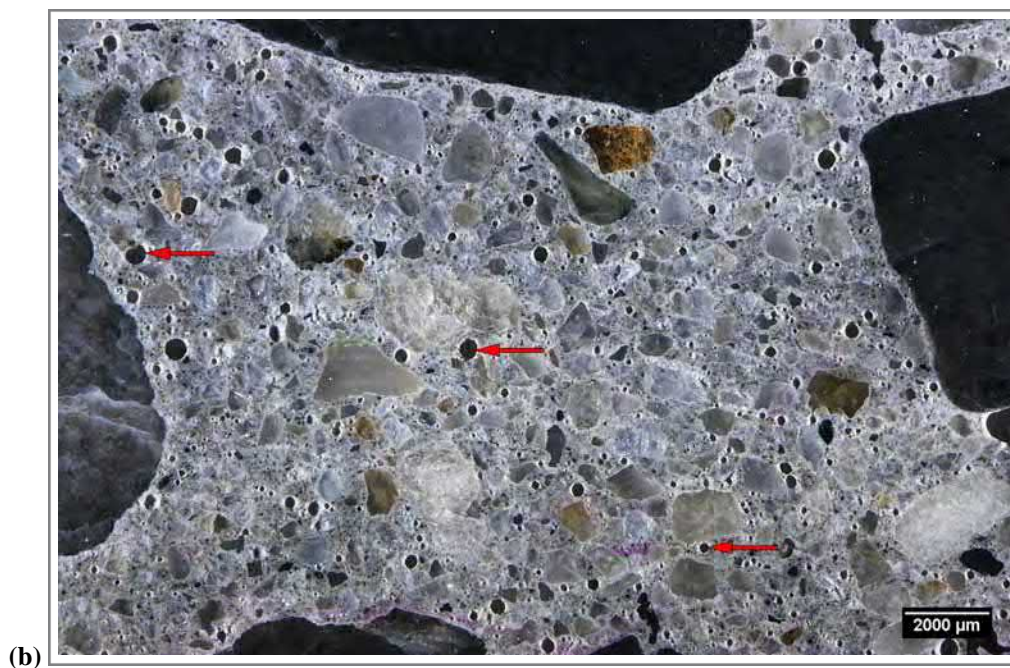
VOID SYSTEM	The concrete is air-entrained and has an estimated 6-7% total air content. Several spherical voids are observed throughout the depth of the core ( <b>Figure D10</b> ). Few entrapped voids are occasionally present throughout the core. The concrete is well consolidated with no notably large entrapped voids.
VOID FILLINGS	Ettringite occasionally lines voids throughout the core ( <b>Figure D11</b> ).

Figure D10. Images showing detail of voids within the core. (a) Reflected light photomicrograph showing detail of voids (red arrows) in the top portion of the core.

**Figure D10 (cont'd).** Images showing detail of voids within the core. (b) Reflected light photomicrograph showing detail of voids (red arrows) in the middle of the core.

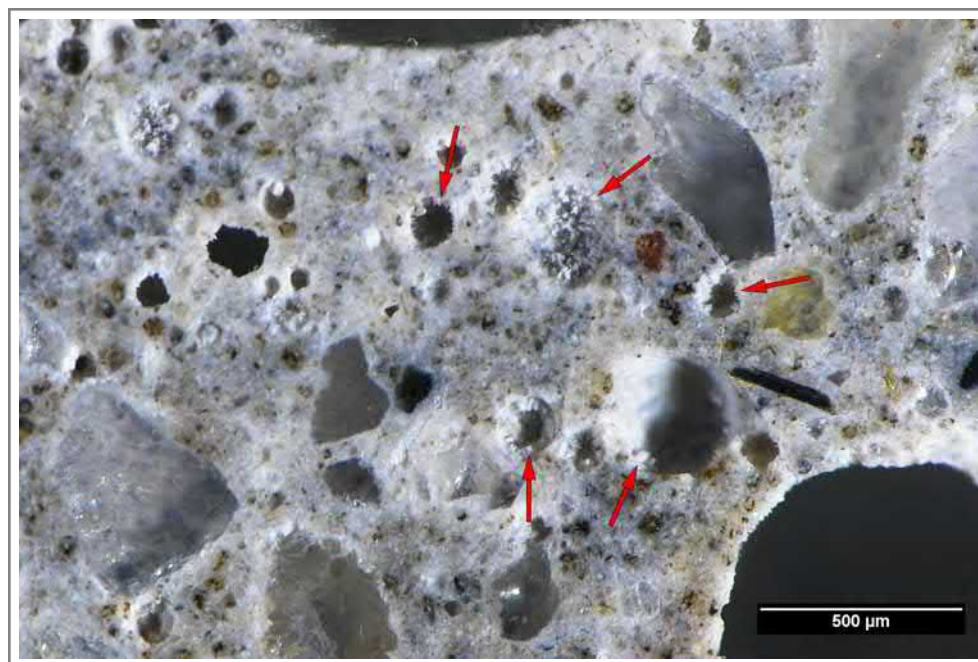
**Figure D11.** Reflected light photomicrograph of the polished surface showing ettringite (red arrows) in several voids within the core.

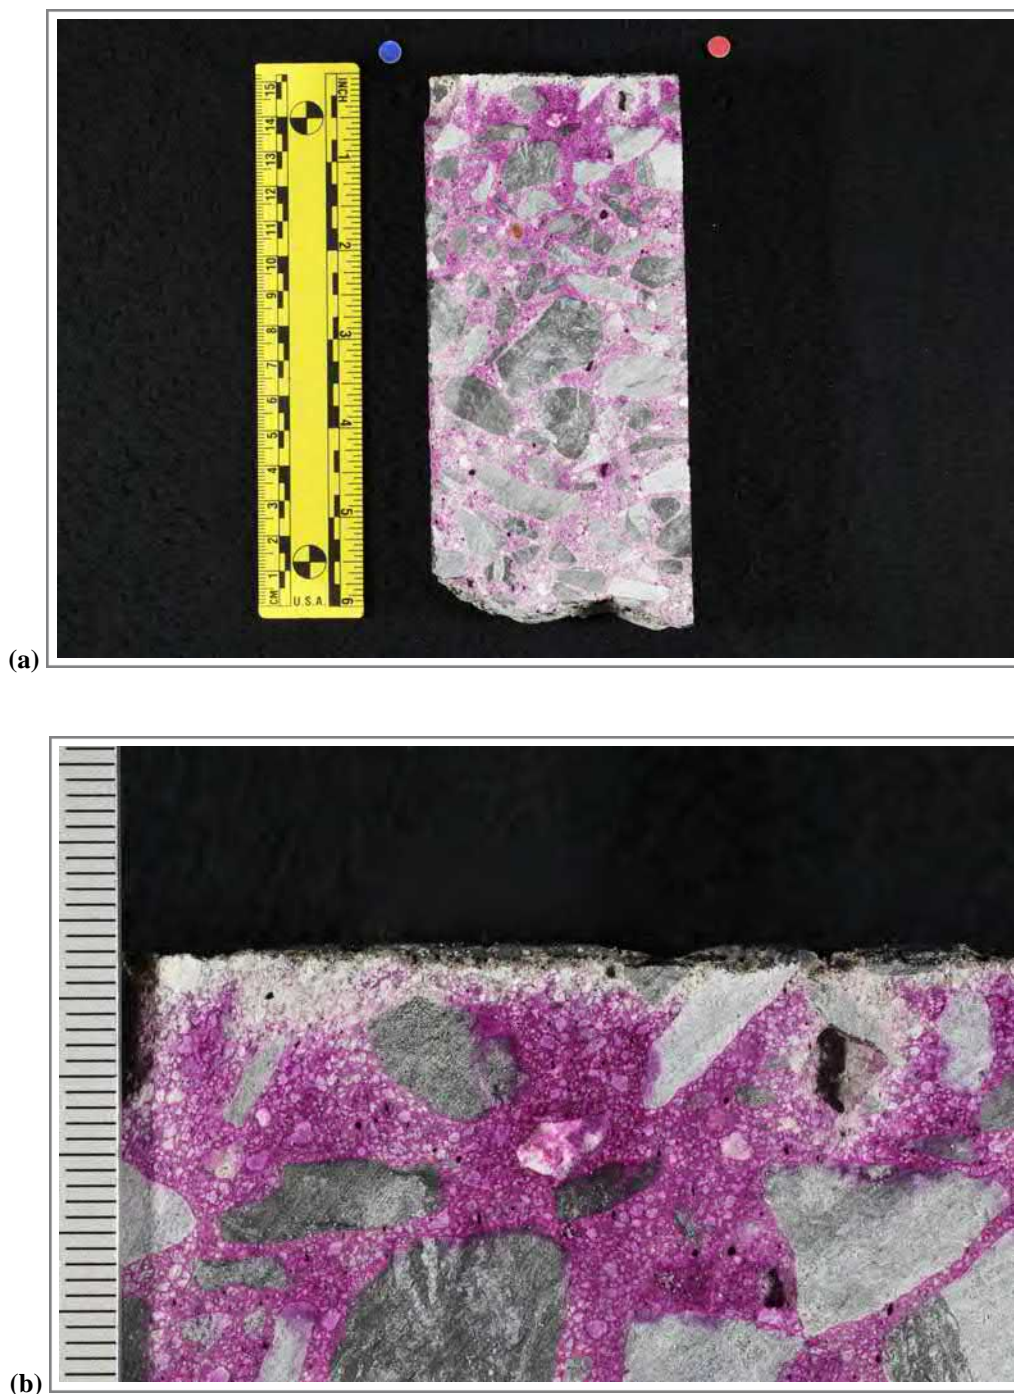
PHENOLPHTHALEIN	The paste is carbonated in the top 1 mm (40 mil) with locally deeper carbonation along sub-vertical microcracks ( <b>Figure D12</b> ). Phenolphthalein staining was applied to a freshly saw-cut cross-sectional surface of the core to determine general depth of paste carbonation.
SECONDARY DEPOSITS	Other than ettringite in voids, no additional secondary deposits are observed.

Figure D12. Photographs showing (a) overview of phenolphthalein-stained cross-sectional surface of the core, and (b) detail of stained surface at the top of the core. The yellow scale in (a) is ~150 mm (6 in.) long; the small and large divisions are in centimeters and inches, respectively. The scale in (b) shows millimeter increments.

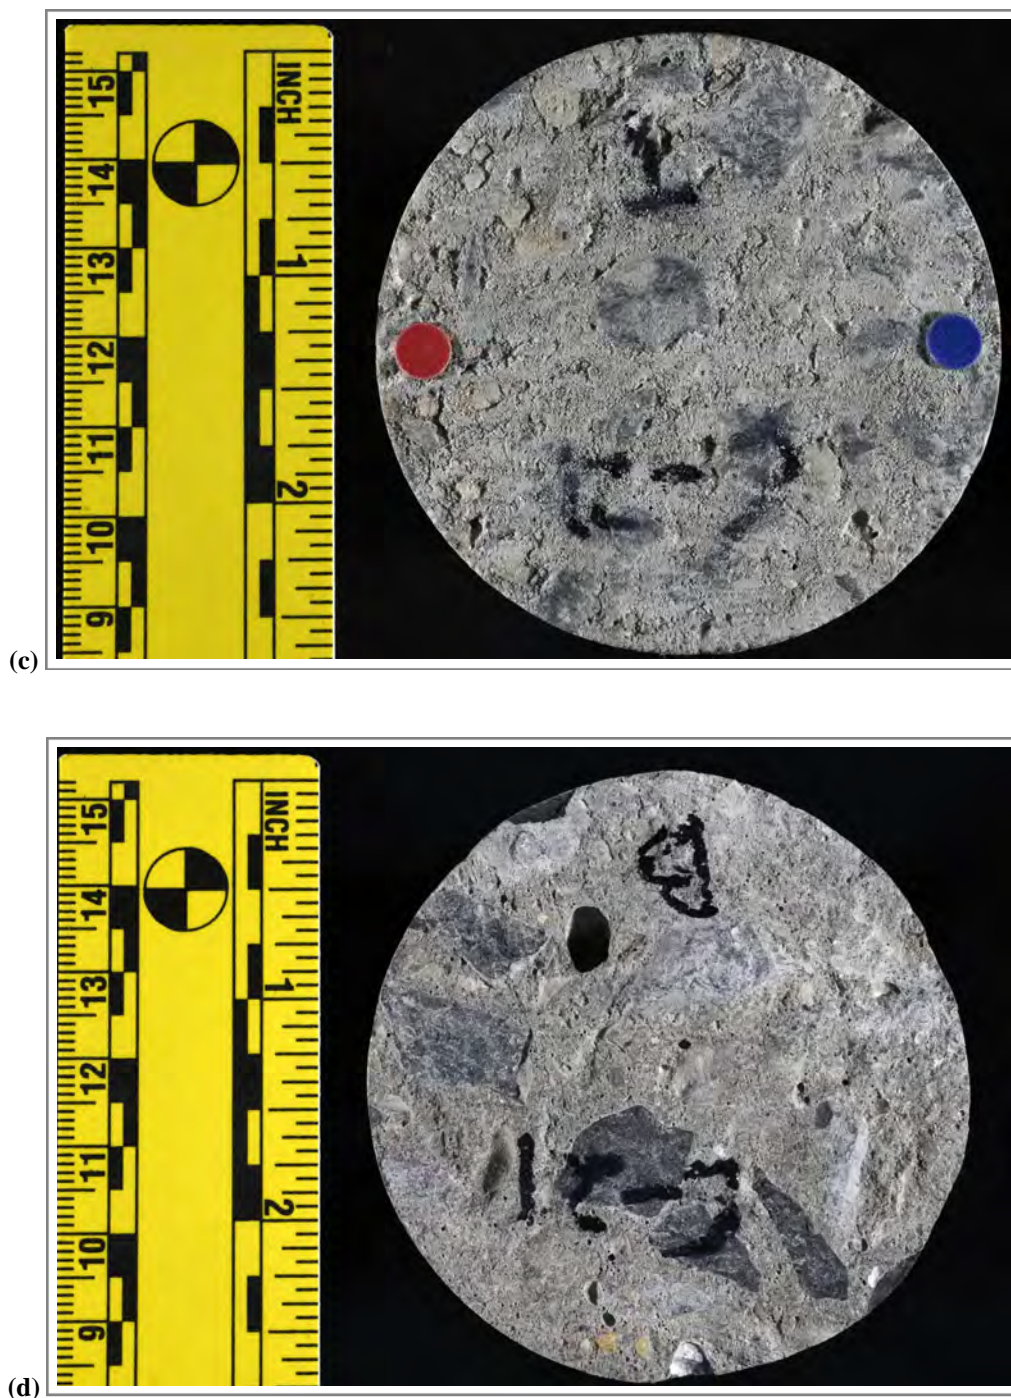
ORIENTATION & DIMENSIONS	Sample is a vertical core measuring ~70 mm (2 ¾ in.) in diameter and ~140 mm (5 ½ in.) in length ( <b>Figure E1</b> ).
SURFACES	The top surface is a worn concrete surface that exhibits exposed coarse aggregate and fine aggregate particles in high relief, and the bottom surface is a rough, uneven, fractured surface ( <b>Figure E1, Figure E2</b> ).
GENERAL CONDITION	The core was received intact in one piece ( <b>Figure E1, Figure E3</b> ).

Figure E1 (cont'd). Photographs of the core in as-received condition showing (c) top surface of the core and (d) the bottom surface of the core. The red and blue dots in (c) show the orientation of the saw cuts used to prepare the core. The yellow scale is ~150 mm (6 in.) long; the small and large divisions are in centimeters and inches, respectively.
